Monitoring Data Record

Project Title: U-2524AC (Greensboro Western Urban Loop) COE Action ID: 200321137

Stream Name: Long Branch (Site 2BA) DWQ Number: 030909

The Long Branch stream relocation is stable for the Year 2 Summer evaluation, except for, some minor bank scouring that still exist at the station numbers noted below. NCDOT will continue to monitor this stream relocation.

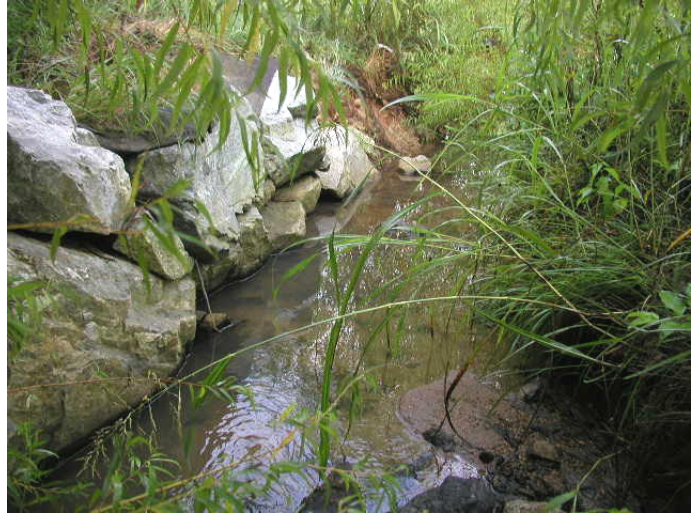
Photo Point #1 (Downstream)

7/27/09	Sta. 11+50 PP#1 Downstream Photo	Sta. 17+50 Additional Photo	Sta. 20+00 PP#5 Downstream Photo	Sta. 23+00 Additional Photo	Sta. 27+00 PP#9 Upstream and Downstream Photo
Structure Type					
Is water piping through or around structure?					
Head cut or down cut present?					
Bank or scour erosion present?	Minor bank scouring on left bank downstream of boulder protection	Minor bank scouring on right bank	Minor bank scouring on left bank	Minor bank scouring on left bank downstream of boulder protection	Minor bank scouring on right and left bank

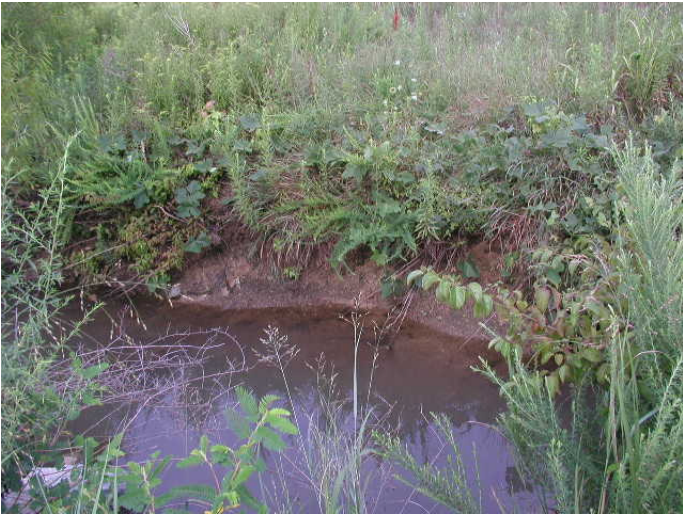
Bank Scouring @ Sta. 17+50

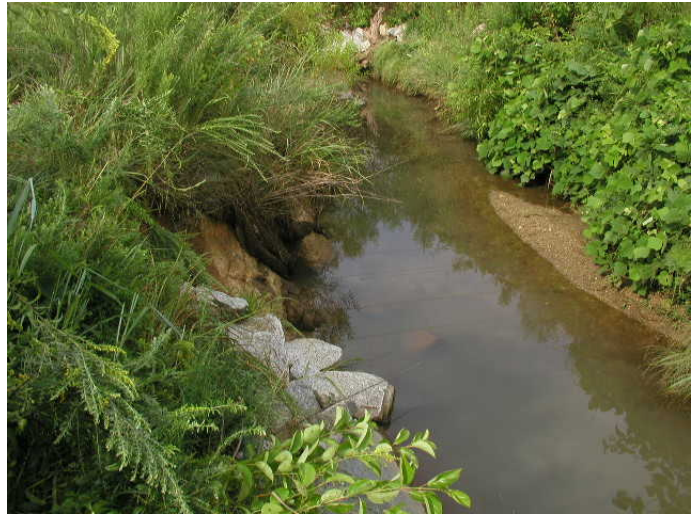
Bank Scouring @ Sta. 23+00 on Left Bank
